**A Study of the Effectiveness of Ground Penetrating Radar
For Assessing Asphalt Covered Reinforced Concrete
Bridge Deck Deterioration**

A Thesis Submitted to the
Faculty of Engineering
in Partial Fulfillment of the Requirements
for the Degree of

Major Subject: Civil Engineering

DALHOUSIE UNIVERSITY – DALTECH

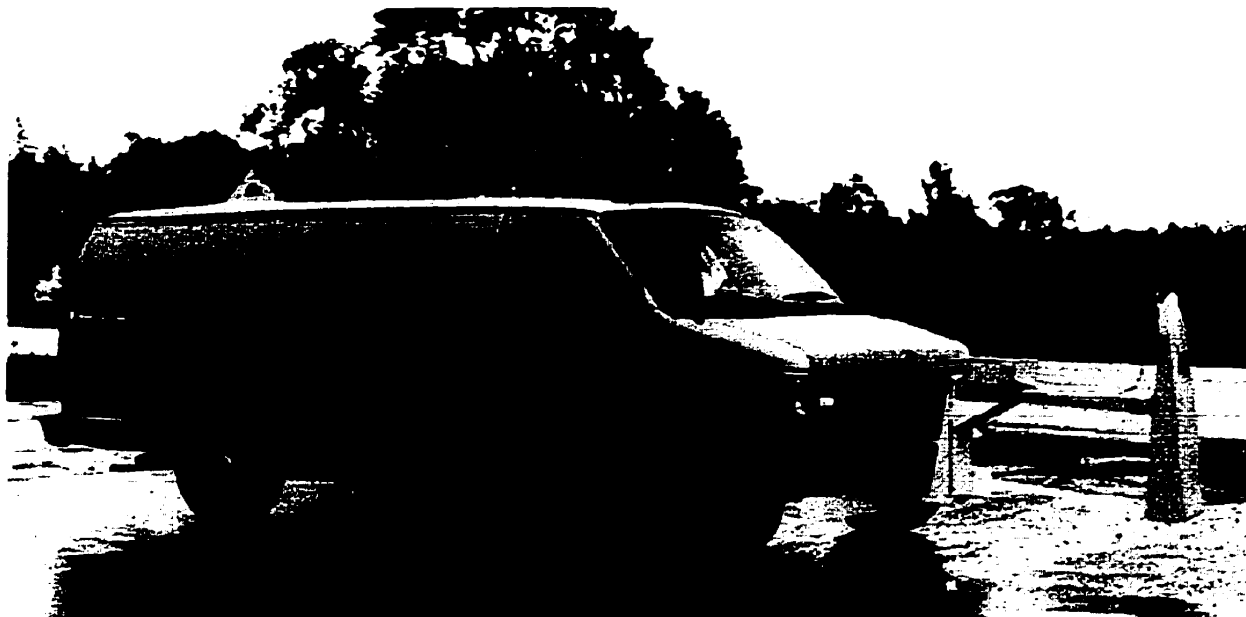
Figure 6 - Van equipped with Penetradar PS-24 Integrated Radar Inspection System

With the identification of the appropriate technology, the Nova Scotia Department of Transportation and Communications was approached by Dalhousie University DalTech with a proposal to lend financial assistance to a five-year term research project in which the use of GPR as a predictive tool for estimating bridge deck deterioration would be undertaken. The GPR system produced by the Penetradar Corporation was selected because of the strong support it had received from the US Federal Highways Administration, Ontario Ministry of Transportation, and many of the above mentioned departments. The five-year research project was approved by the Nova Scotia Department of Transportation and Public Works and the Penetradar Integrated Radar Inspection System (IRIS) shown in Figure 6, was purchased in the summer of 1996.

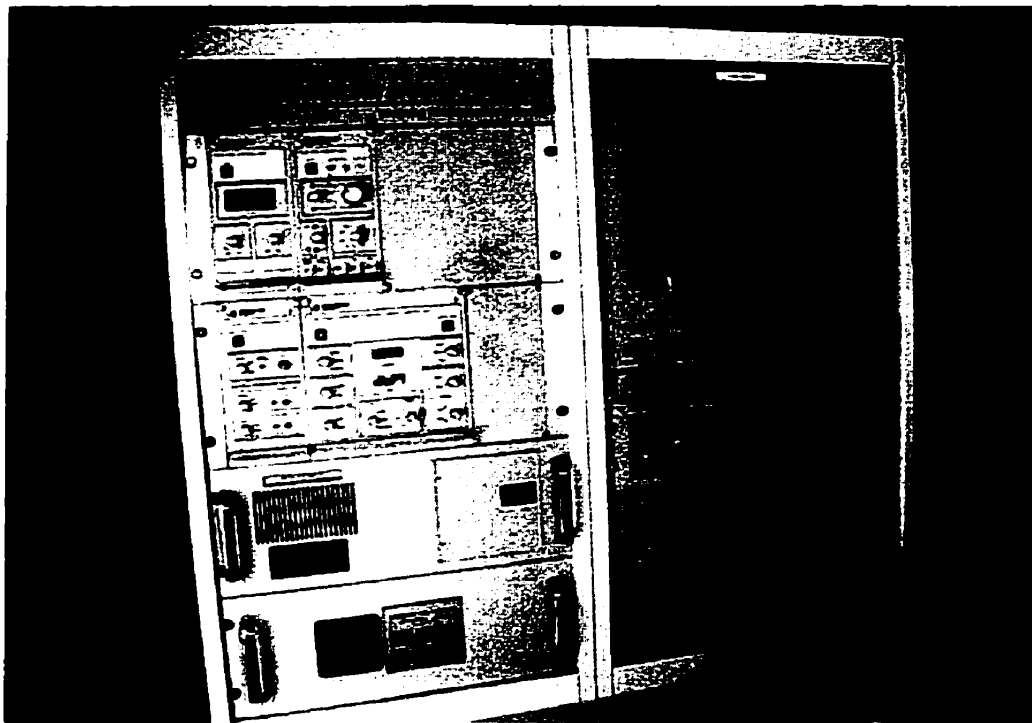
Figure 7 - GPR control hardware contained inside research vehicle.

cargo van and is also used to charge 2 large wet-cell batteries located in the rear storage area of the van. These two batteries are used to power the equipment if the van is not running and also for charging the radar battery pack. The radar battery pack provides a short-term supply of relatively constant voltage to the radar control unit, enabling constant transmitted signal power. Since the inception of this research project the battery pack has been replaced with a circuit supplying constant power to the radar control unit. This eliminated the need to recharge the battery pack and tends to produce output of a more uniform amplitude. The master control unit controls the timing and shape of the transmitted signal, signaling the transmitter/receiver unit which is located on the exterior hardware that is installed on the antenna configuration on the front of the van. The distance measuring device control receives electronic pulses from the ABS braking system and has them recorded along with the radar data for distance measurement.

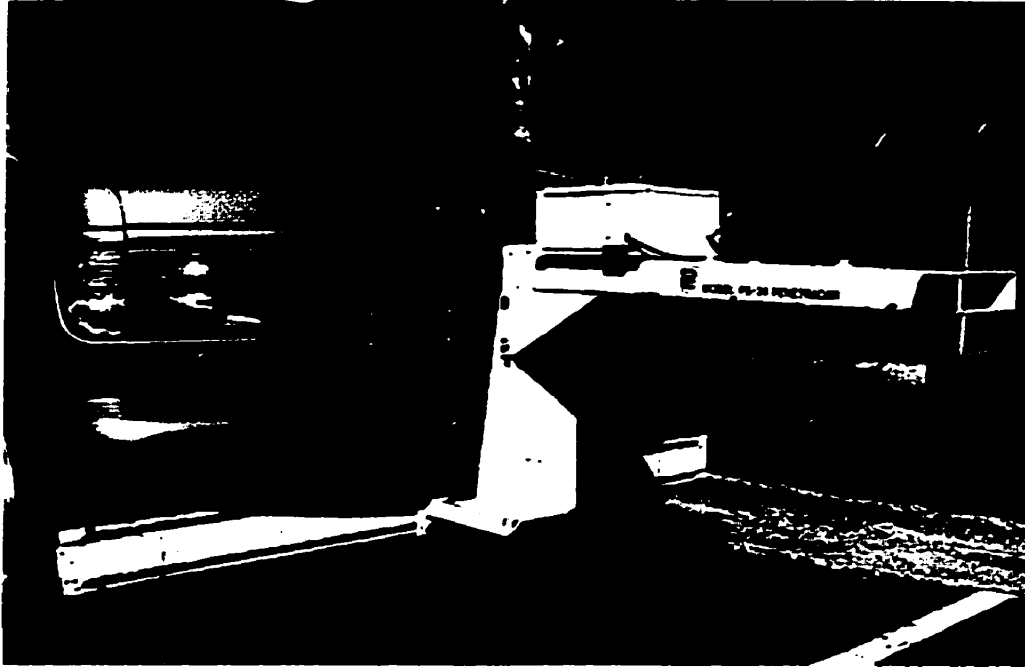
Figure 8 - Exterior antenna assembly on front of van

Exterior hardware includes the transmitter/receiver unit, antenna, and antenna support structure. This assembly is shown in Figure 8 below.

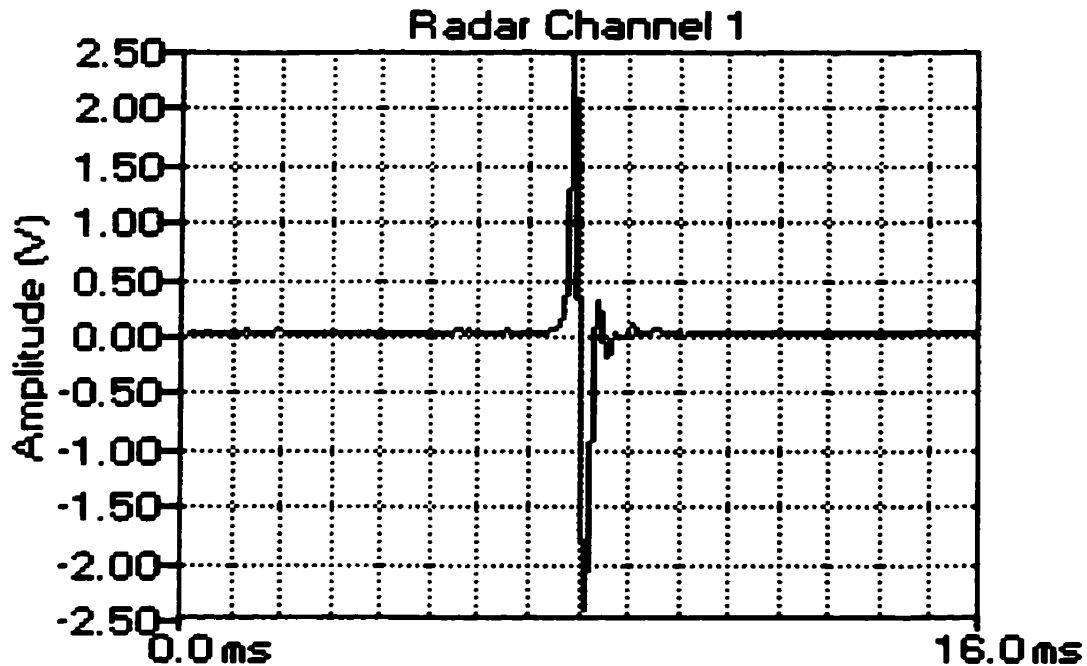
Figure 9 -Typical transmitted radar impulse signal

for measurement of thinner layers, but attenuate more rapidly than longer pulsewidths which have a greater penetration depth, but lower thickness resolution.

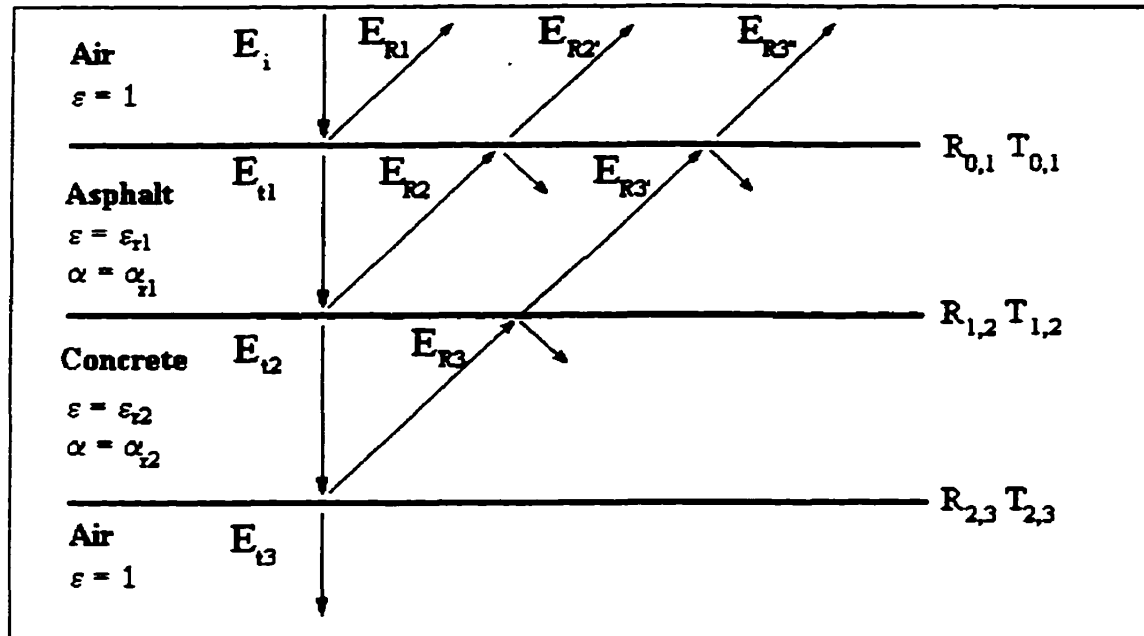
Figure 10 - Ray diagram of energy reflection and transmission from a bridge deck

Figure 10 shows a simple ray diagram depicting the incident and reflected energy portions of the original transmitted beam from the antenna. By accounting for the transmission and reflection of energy from each interface in the system, we can formulate equations to model the expected response in the recorded radar waveform.

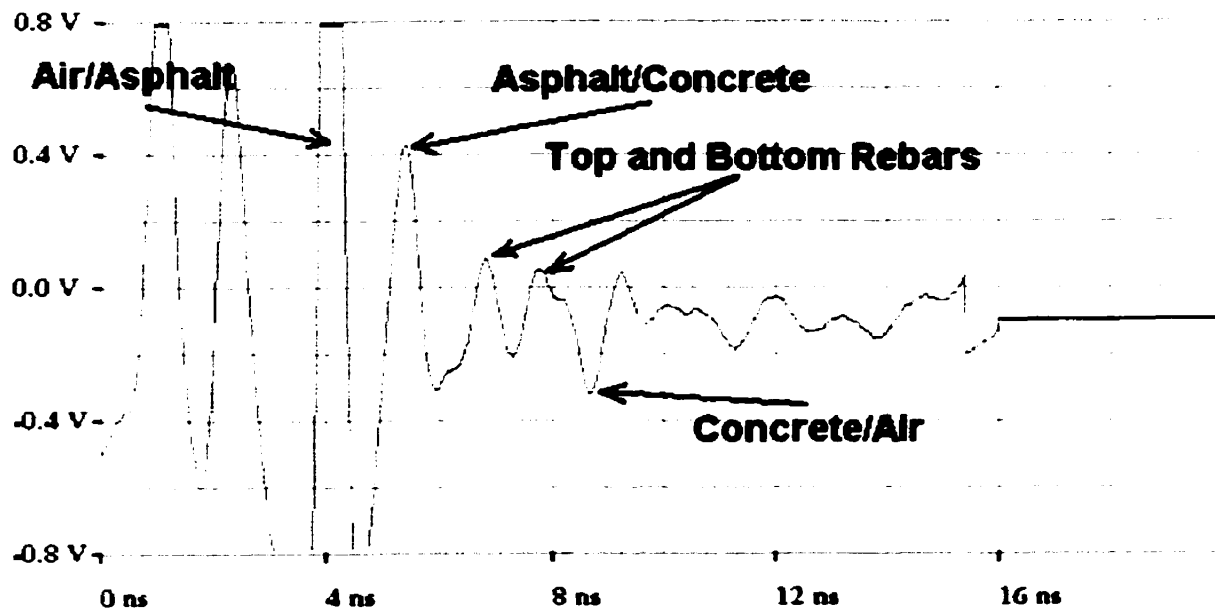
Figure 11 - GPR waveform recorded from typical asphalt paved bridge deck

Figure 11 shows a waveform recorded from an actual bridge deck. The waveform is the recorded voltage, or signal strength, of the reflected signal versus time. The expected peaks of the air/asphalt, asphalt/concrete, and concrete/air interfaces can be seen within the waveform along with positively oriented peaks corresponding to the upper and lower layers of steel reinforcement. The two initial peaks arriving prior to the four nanosecond location are internal reflections of the antenna and GPR hardware.

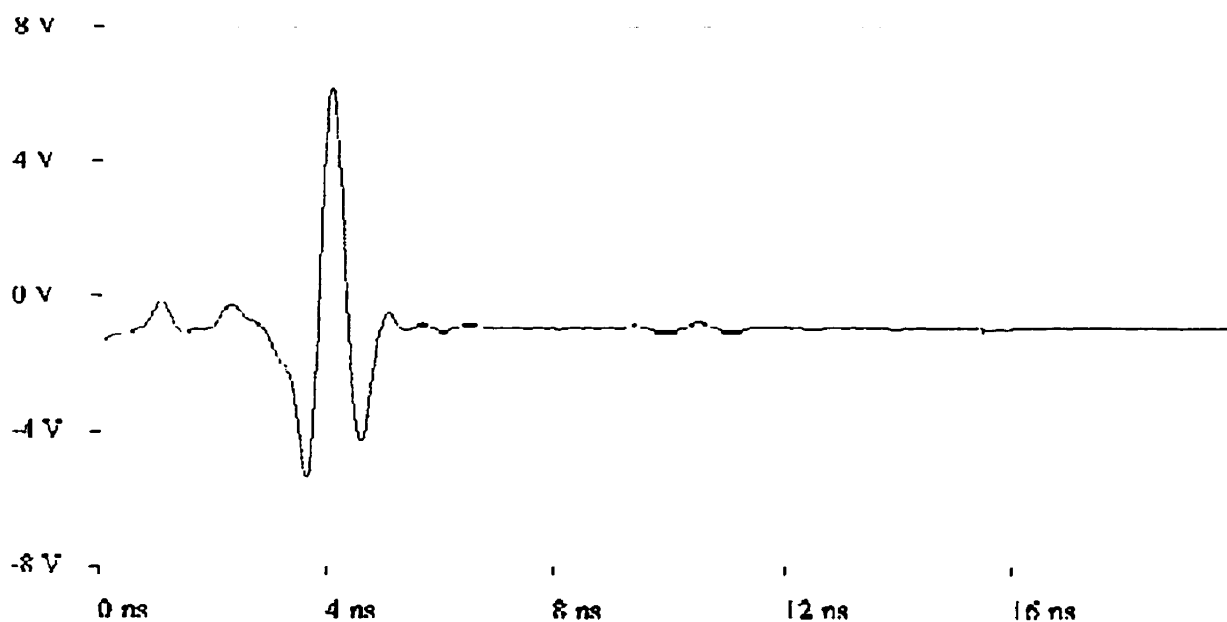
Figure 12 - Sample of a flat metal plate calibration file

is generally assumed to be unity, simplifying the problem of calculating the top material layer relative dielectric constant, which is asphalt in the simplistic bridge deck model under consideration. The incident voltage is not obtained from the radar waveform, but from one of two calibration files that are normally recorded during data collection. The first is called the *flat metal plate* file and is recorded to determine the incident voltage at the interface between air and the top material layer. A sample of a flat metal plate calibration file is shown in Figure 12.

Data is recorded with the antenna positioned at operating height over a 36"X48" flat metal plate. The transmitted energy is reflected wholly from the flat metal plate back to the receiver and is recorded. The magnitude of the reflection from the flat metal plate represents the incident voltage transmitted to the interface of the first air layer and the following layer. Figure 13 shows the antenna positioned over the flat metal plate for recording this file.

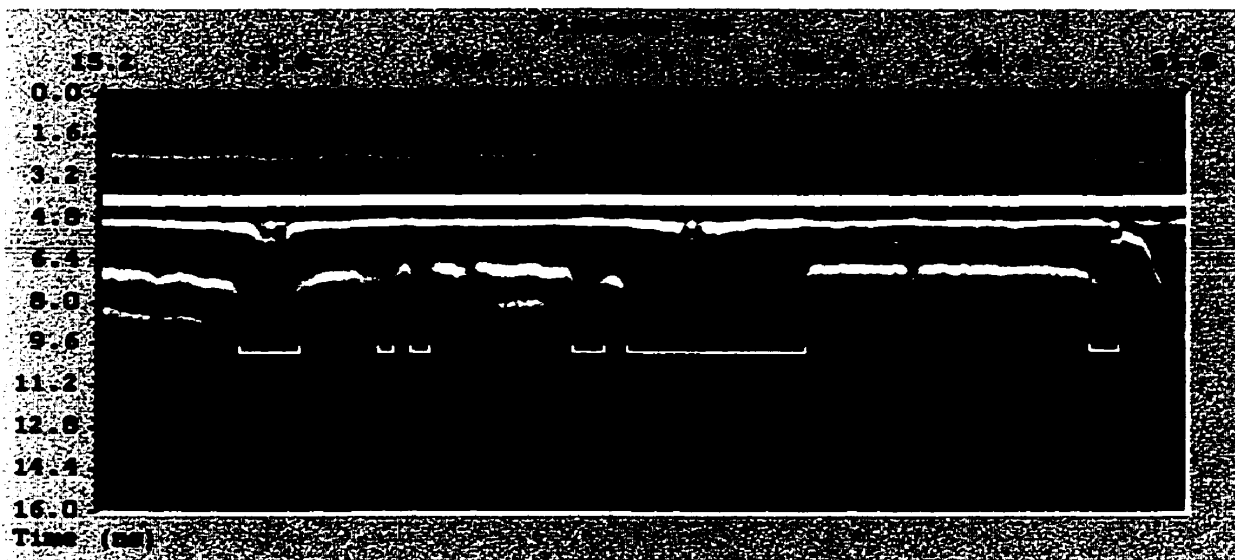
Figure 16 - GPR deck data indicating areas of deterioration

Quantification of the degree of attenuation may lead to a relationship between bottom reinforcement delamination and the most severely attenuated signals.

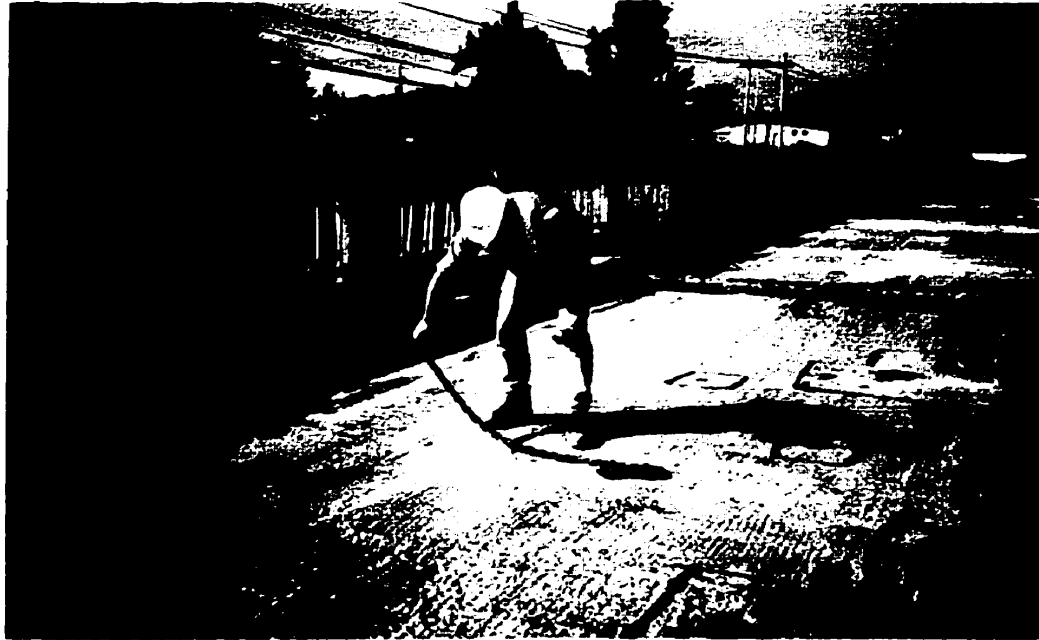
Figure 17 - Conducting the chain drag survey

The test is simple, but relies on the operator's interpretation of the sound resulting from the chain being dragged over the exposed concrete surface. On undamaged concrete, the chain results in a sharp, ringing sound whereas on deteriorated concrete, the sound is dull and hollow. Various degrees of cracking severity and gap opening will affect the sound produced. The entire surface of the deck is sounded using the chain in this manner. The boundary of each detected deteriorated area found with the chain are delineated using spray paint. These areas are simplified into rectangular shapes for ease of saw-cutting, removal and repair. Also, groups of small designated repairs are often grouped together to form a larger rectangular area or interconnected group of rectangular shapes to simplify the repair work, including sound areas of concrete with deteriorated areas in the repair.

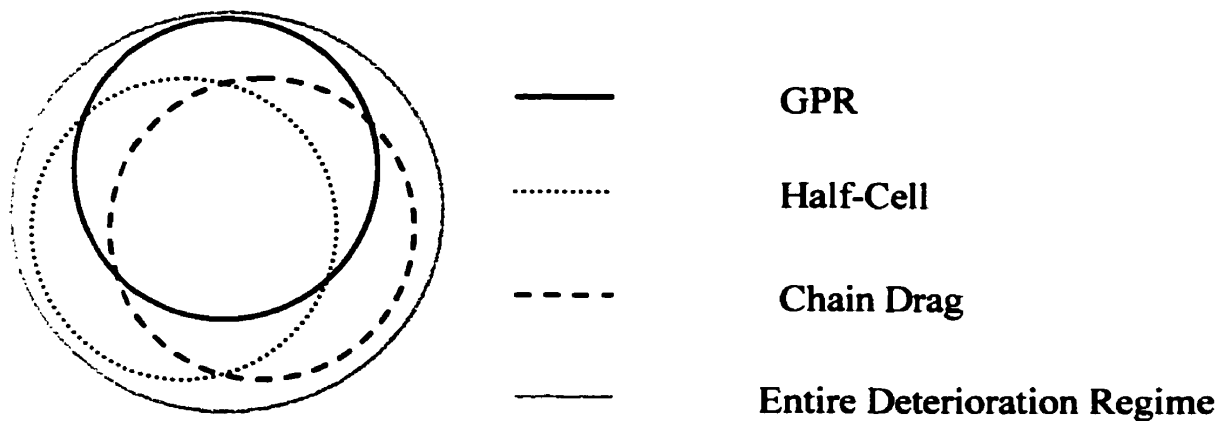
Figure 19 - Diagram showing convergence and divergence of test methods

It is important to understand that each of the test methods used in this research is an estimate of a deterioration symptom of the entire deterioration process. These symptoms can correspond to timeframes of the entire deterioration process ranging from initial moisture and chloride ingress into the slab to complete corrosion and delamination of the slab. Figure 19 describes how these methods approximate the actual deterioration regime by considering different symptoms. The predicted areas of these methods based on these symptoms will tend to have areas of confluence and divergence depending on the age of the deterioration process for each localized area of the bridge deck under study. GPR is used to locate areas of excess moisture and chloride, the half-cell potential survey is used to locate areas of active corrosion, and the chain drag survey is used to locate areas of concrete that have cracked or debonded from the top mat of reinforcement due to corrosion. Using these methods to assess the accuracy of GPR implies that all methods are expected to produce similar results. However, given the range of time frames that different symptoms represent, it follows that a significant level of divergence among the results must be expected.
